TECHNICAL SERVICE BULLETIN

Bulletin No.: TSB-024

Subject: Improved Cover Fastener

Models: Gen 2 Back Of Cab Fuel Storage Modules

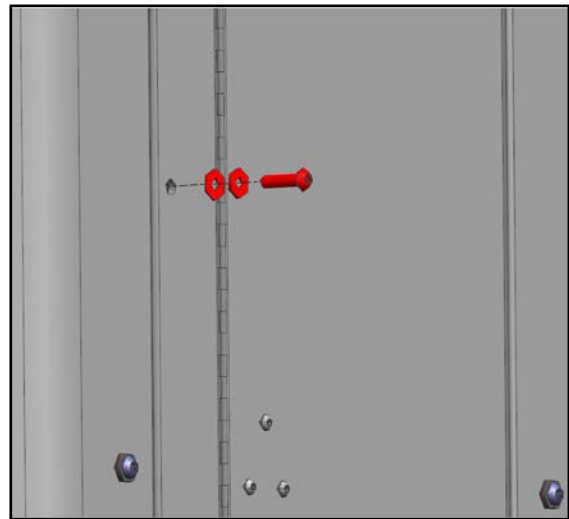
A number of customers have reported loosening or the loss of fasteners retaining the covers on the Gen 2 Back Of Cab (BOC) systems.

Vibration and relative motion between the cover panels may cause the fasteners to loosen. In addition, slight variances in torque application may result in uneven joint pressure which may contribute to the loss of fastener torque and eventual fastener loss.

Quantum will supply replacement fasteners for any cover fasteners that continue to loosen after proper installation or have been found missing. An alternate replacement fastener has been released that includes a coating that performs a locking function; this coating will inhibit loosening of the fasteners caused by vibration and motion of the panels.

Installation torque of the improved fastener is the same as the original fastener. 71 lb.in (8 N.m.)
