**TECHNICAL SERVICE BULLETIN****Bulletin No.:** CYL-TSB-007**Date:** October 1, 2014**Subject:** Integrated Isolator Over-Wrap Separation**Models:** Cylinders With Integrated Isolators**Background**

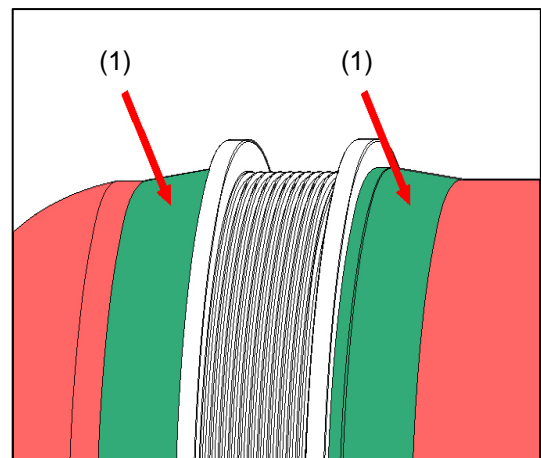
Some cylinders have been constructed with the isolator integrated directly with the cylinder. The isolator is made of rubber and is fixed to the cylinder using wings that extend from the sides of the isolator groove. The wings are held in place under numerous layers of carbon fiber and resin called the over-wrap (1).

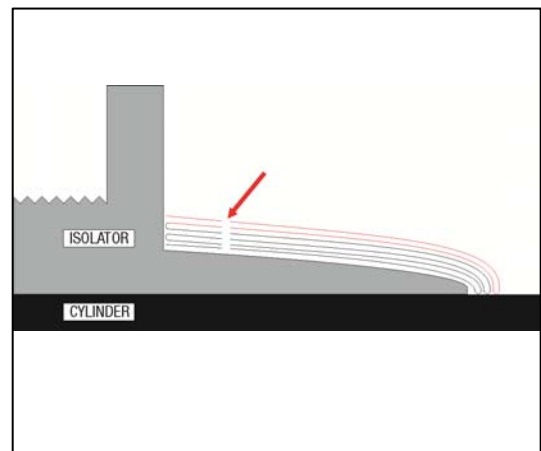
In some cases, the over-wrap carbon fiber which is used to hold the integrated isolator onto the surface of the cylinder may experience a separation (2) in the fiber.

The CNG cylinder is a finished product that is structurally sound prior to the application of the rubber isolator and the carbon fiber over-wrap used to retain it. The flexible rubber isolator is then applied to the cylinder and wound in using the carbon fiber over-wrap and epoxy. Separation may occur in the carbon fiber over-wrap due to normal movement between the cylinder and the rubber isolator.

No corrective action is required.

The over-wrap is a non-structural component of the cylinder. The separation within the over-wrap is cosmetic and not a cause for concern. The separation may be covered with a flexible sealer (such as silicone) for appearances if desired.
